NBS TECHNICAL NOTE 811

Evaluation of the Column Connections Used in a Precast Concrete Modular Housing System

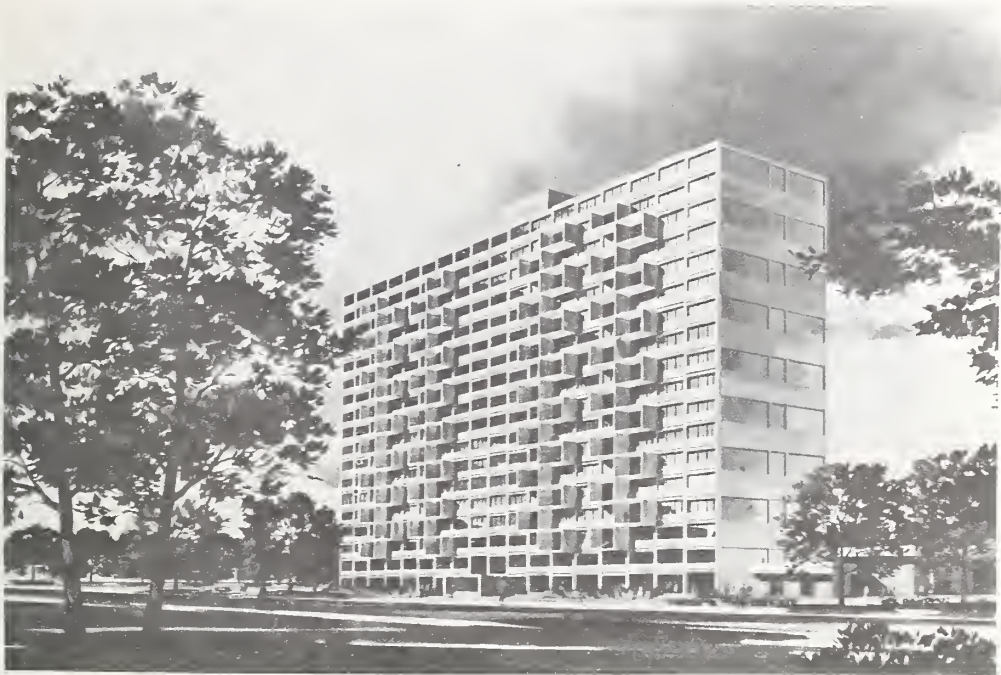
Figure 2.1. Proposed Building

The proposed system consisted of precast reinforced light-weight concrete box modules, stacked in a checkerboard pattern. Figure 2.1 shows one of the buildings proposed for construction, a 19-story structure. Figure 2.2 shows the model of a complex of buildings which is under construction using the structural concepts and connection details evaluated in this report, however, the modules differ in size and configuration from those proposed for the structure shown in figure 2.1.

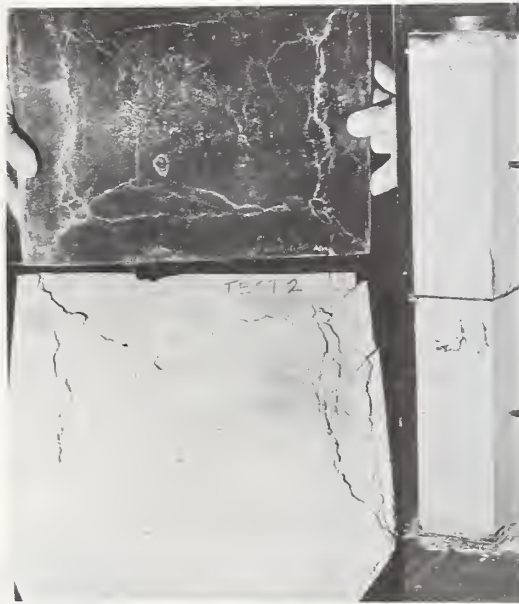
Figure 4.5. Typical Failure of Connection Using 1/4-in Neoprene Pad

Figure 4.5 shows a typical failure of a connection using a neoprene pad. The spalling between the core inside the ties and the shell outside the ties is an indication that at ultimate load the core supported most of the load. The same observation can be made in figure 4.6 which shows the typical failure of a grouted connection.

The results for all the tests are presented in tables 4.1.2, 4.1.3 and 4.1.4. Typical failure modes are illustrated in figures 4.5 through 4.9.

The effect of the type of bearing pad on the mode of failure can be observed in figures 4.5 to 4.9.

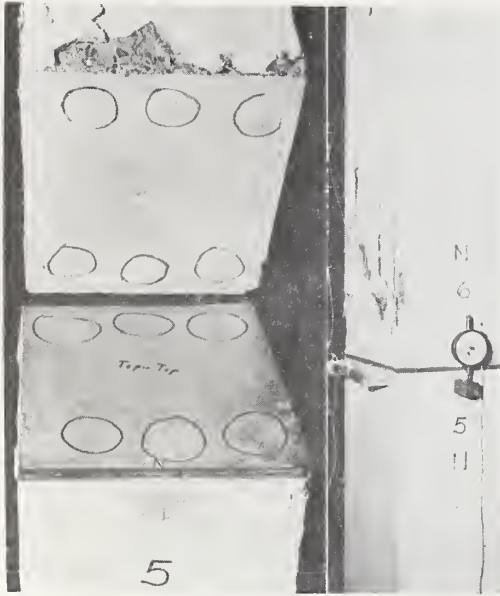
Figure 4.7 Typical Failure of Connection Using a Steel-Neoprene-Steel Sandwich

On the other hand, it can be seen from figure 4.7 that in the specimens using the steel-neoprene-steel sandwich there was no spalling of the shell, and thus, the entire cross-sectional area contributed to the load resistance. It can also be seen in this figure that the concrete bearing surface is

smooth and locally deformed with protruding imprints of the main reinforcing bars. The deformation is probably attributable to plastic flow of the concrete before failure which is taken as an indication of triaxial confinement. The imprint of the bars was caused by bond breakage near the end of the bars where the strain in the concrete could not be transmitted to the steel bars.

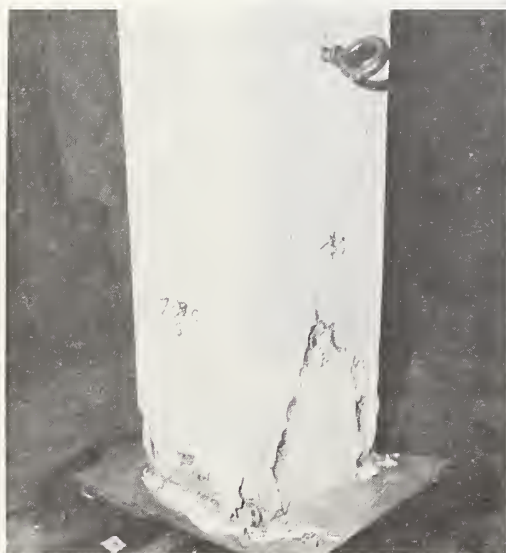
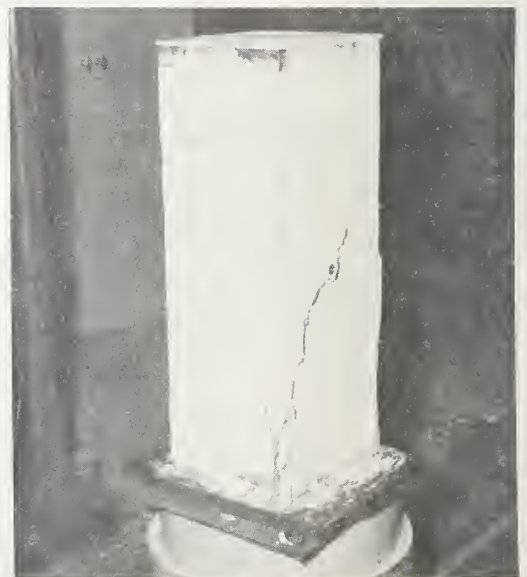
Figure 4.9. Failure of Column Stub Bearing on a Steel Plate Covered by a Low Friction Membrane

The failure of the column stub that was bedded in high-strength gypsum plaster, which is shown in figure 4.8, occurred in the middle of the column above the region of the additional confining ties. This is taken as an indication that in this case the effect of the confinement was even greater than that provided by the steel-neoprene-steel sandwich. On the other hand, the failure mode of the column stub which was tested with a low-friction membrane at the column face and is shown in figure 4.9, gives clear evidence of spalling of the shell.
